# M.J. Hickey Plant Hire Ltd

INVOICE

Supply 14t Duck Self drive

Yew Hill Reservoir

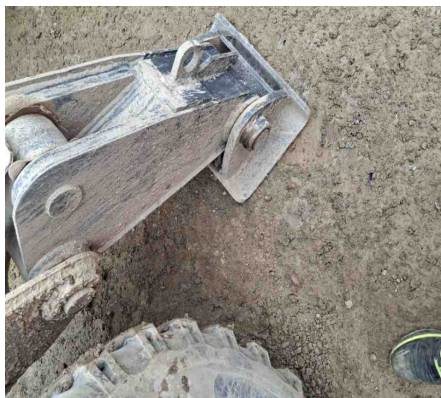
Wheel Position: B1 - Repair Reason

| Pos | Tyre Size | Tread Depths | | | Ply | PSI | | Brand | Condition | Service<br>able | Disposal | Comment |
|---|---|---|---|---|---|---|---|---|---|---|---|---|
| B1 | 10.00-20 | 13 | 16 | 20 | 16 | 1.0 | 100.0 | SUPREME | Average | Y | N | Repair Internal. Reason: Hole. Damage Size: 1mm |

| DESCRIPTION | QTY | PRICE | VALUE |
|---|---|---|---|
| URGENT - SPECIALIST REPAIR<br>CIB: WILL , 07879671965<br>Site Contact: MICHAEL , 07446988887<br>Customer portal advised ETA of: 12/06/2026 12:15<br>1X SPEC REPAIR<br>POSITION REAR LEFT OUTTER (B1)<br>Vehicle Type: 6<br>1 X SUB REPAIR.<br>SPECIALIST SUB<br>This invoice refers to Advice Note JC294826 | 1 | 145.50 | 145.50 |

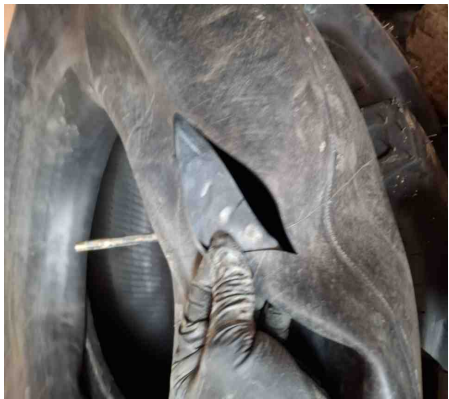
Wheel Position: B2 - Repair Reason

| Pos | Tyre Size | Tread Depths | | | Ply | PSI | | Brand | Condition | Service<br>able | Disposal | Comment |
|---|---|---|---|---|---|---|---|---|---|---|---|---|
| B2 | 10.00-20 | 13 | 18 | 27 | 16 | 13.0 | 100.0 | ALLIANCE | Average | Y | N | Repair Internal. Reason: Hole. Damage Size: 1mm |

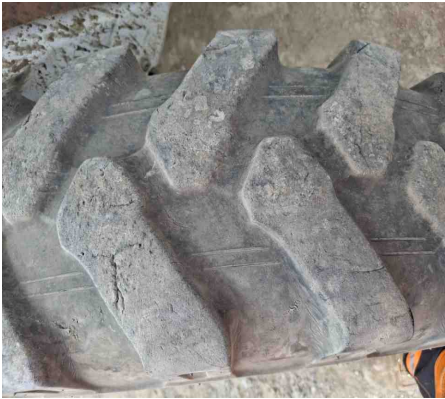
Wheel Position: B4 - Removed Damage Size

| B4 | 10.00-20 | 12 | 15 | 22 | 16 | 0.0 | SUMO | Very Poor | N | Y | Reason: Other. Damage Size: 25mm | |

| Pos | Tyre Size | Tread Depths | | | Ply | PSI | | Brand | Condition | Service able | Disposal | Comment |
|---|---|---|---|---|---|---|---|---|---|---|---|---|
| B4 | 10.00-20 | 15 | 20 | 26 | 16 | 10.0 | 100.0 | ALLIANCE | New Tyre | Y | N | NEW TYRE |

| DESCRIPTION | QTY | PRICE | VALUE |
|---|---|---|---|
| ALIANC 10.00-20 16PR 839 TT | 1 | 491.00 | 491.00 |
