# M.J. Hickey Plant Hire Ltd

INVOICE

Supply 14t Duck Self drive

Yew Hill Reservoir

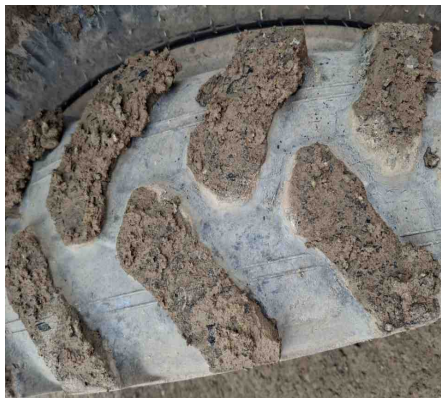
Wheel Position: B1 - Tread Before

| Pos | Tyre Size | Tread Depths | | | Ply | PSI | | Brand | Condition | Service<br>able | Disposal | Comment |
|---|---|---|---|---|---|---|---|---|---|---|---|---|
| B1 | 10.00-20 | 13 | 16 | 20 | 16 | 1.0 | 100.0 | SUPREME | Average | Y | N | Repair Internal. Reason: Hole. Damage Size: 1mm |

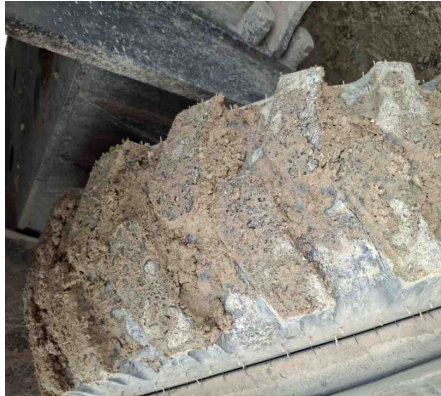
Wheel Position: B2 - Tread Before

| Pos | Tyre Size | Tread Depths | | | Ply | PSI | | Brand | Condition | Service<br>able | Disposal | Comment |
|---|---|---|---|---|---|---|---|---|---|---|---|---|
| B2 | 10.00-20 | 13 | 18 | 27 | 16 | 13.0 | 100.0 | ALLIANCE | Average | Y | N | Repair Internal. Reason: Hole. Damage Size: 1mm |

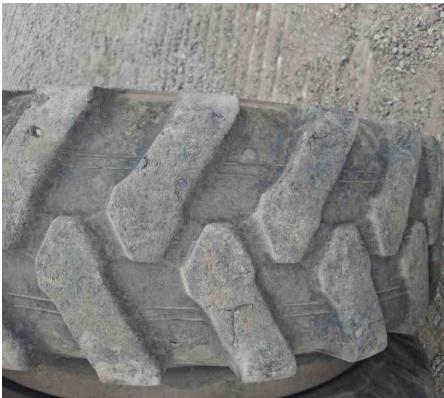
Wheel Position: B4 - Tread Before

| B4 | 10.00-20 | 12 | 15 | 22 | 16 | 0.0 | SUMO | Very Poor | N | Y | Reason: Other. Damage Size: 25mm | |
